August 27, 2019  
File No. 132473-003

Subject: Weekly Monitoring Report for Week Ending 08/17/2019  
Florence Copper, Production Test Facility  
Aquifer Protection Permit No. 106360, LTF 61845

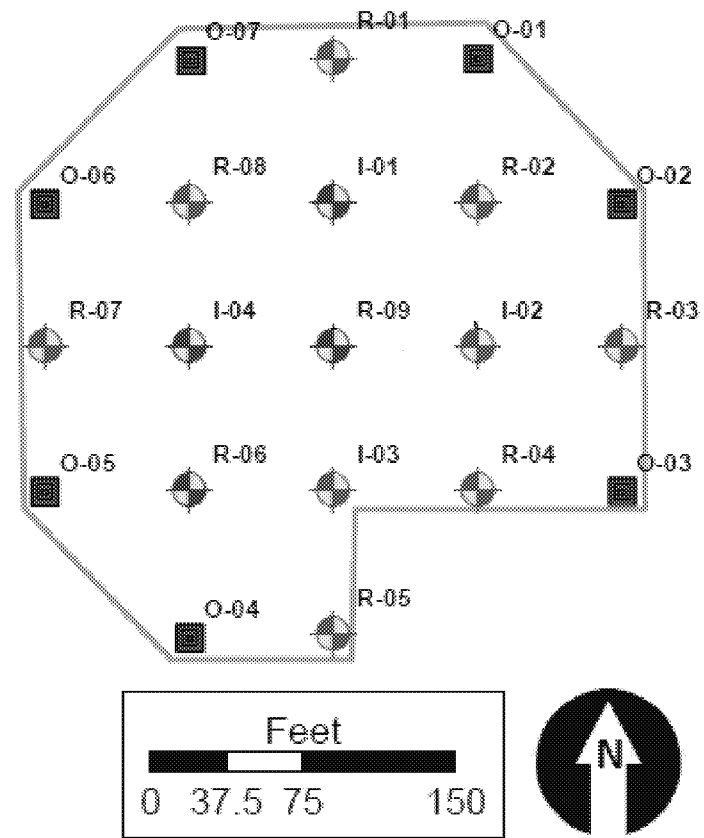
Figure 1. PTF injection, recovery, and observation well locations

A map showing the location of the PTF injection, recovery, and observation wells is included as Figure 1.

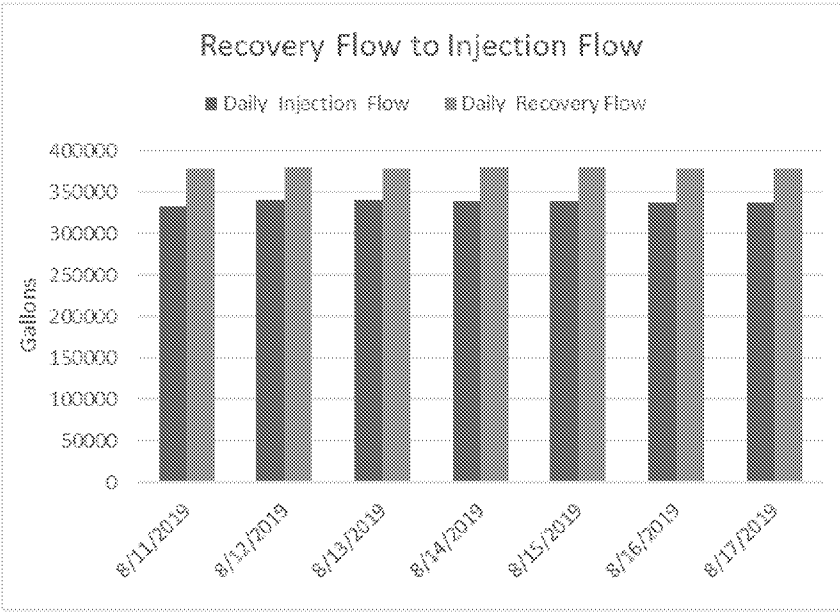
Figure 2. Recovered volume to injected volume

A summary of the injected and recovered volumes for the week of 08/11/2019 to 08/17/2019 is included in Table 1. The total injected and recovered volumes for the PTF as a daily total are also presented on Figure 2.

During the reporting period no exceedance of the alert level was measured for recovered volume to injected volume. The alert level is the recovered volume shall exceed the injected volume.

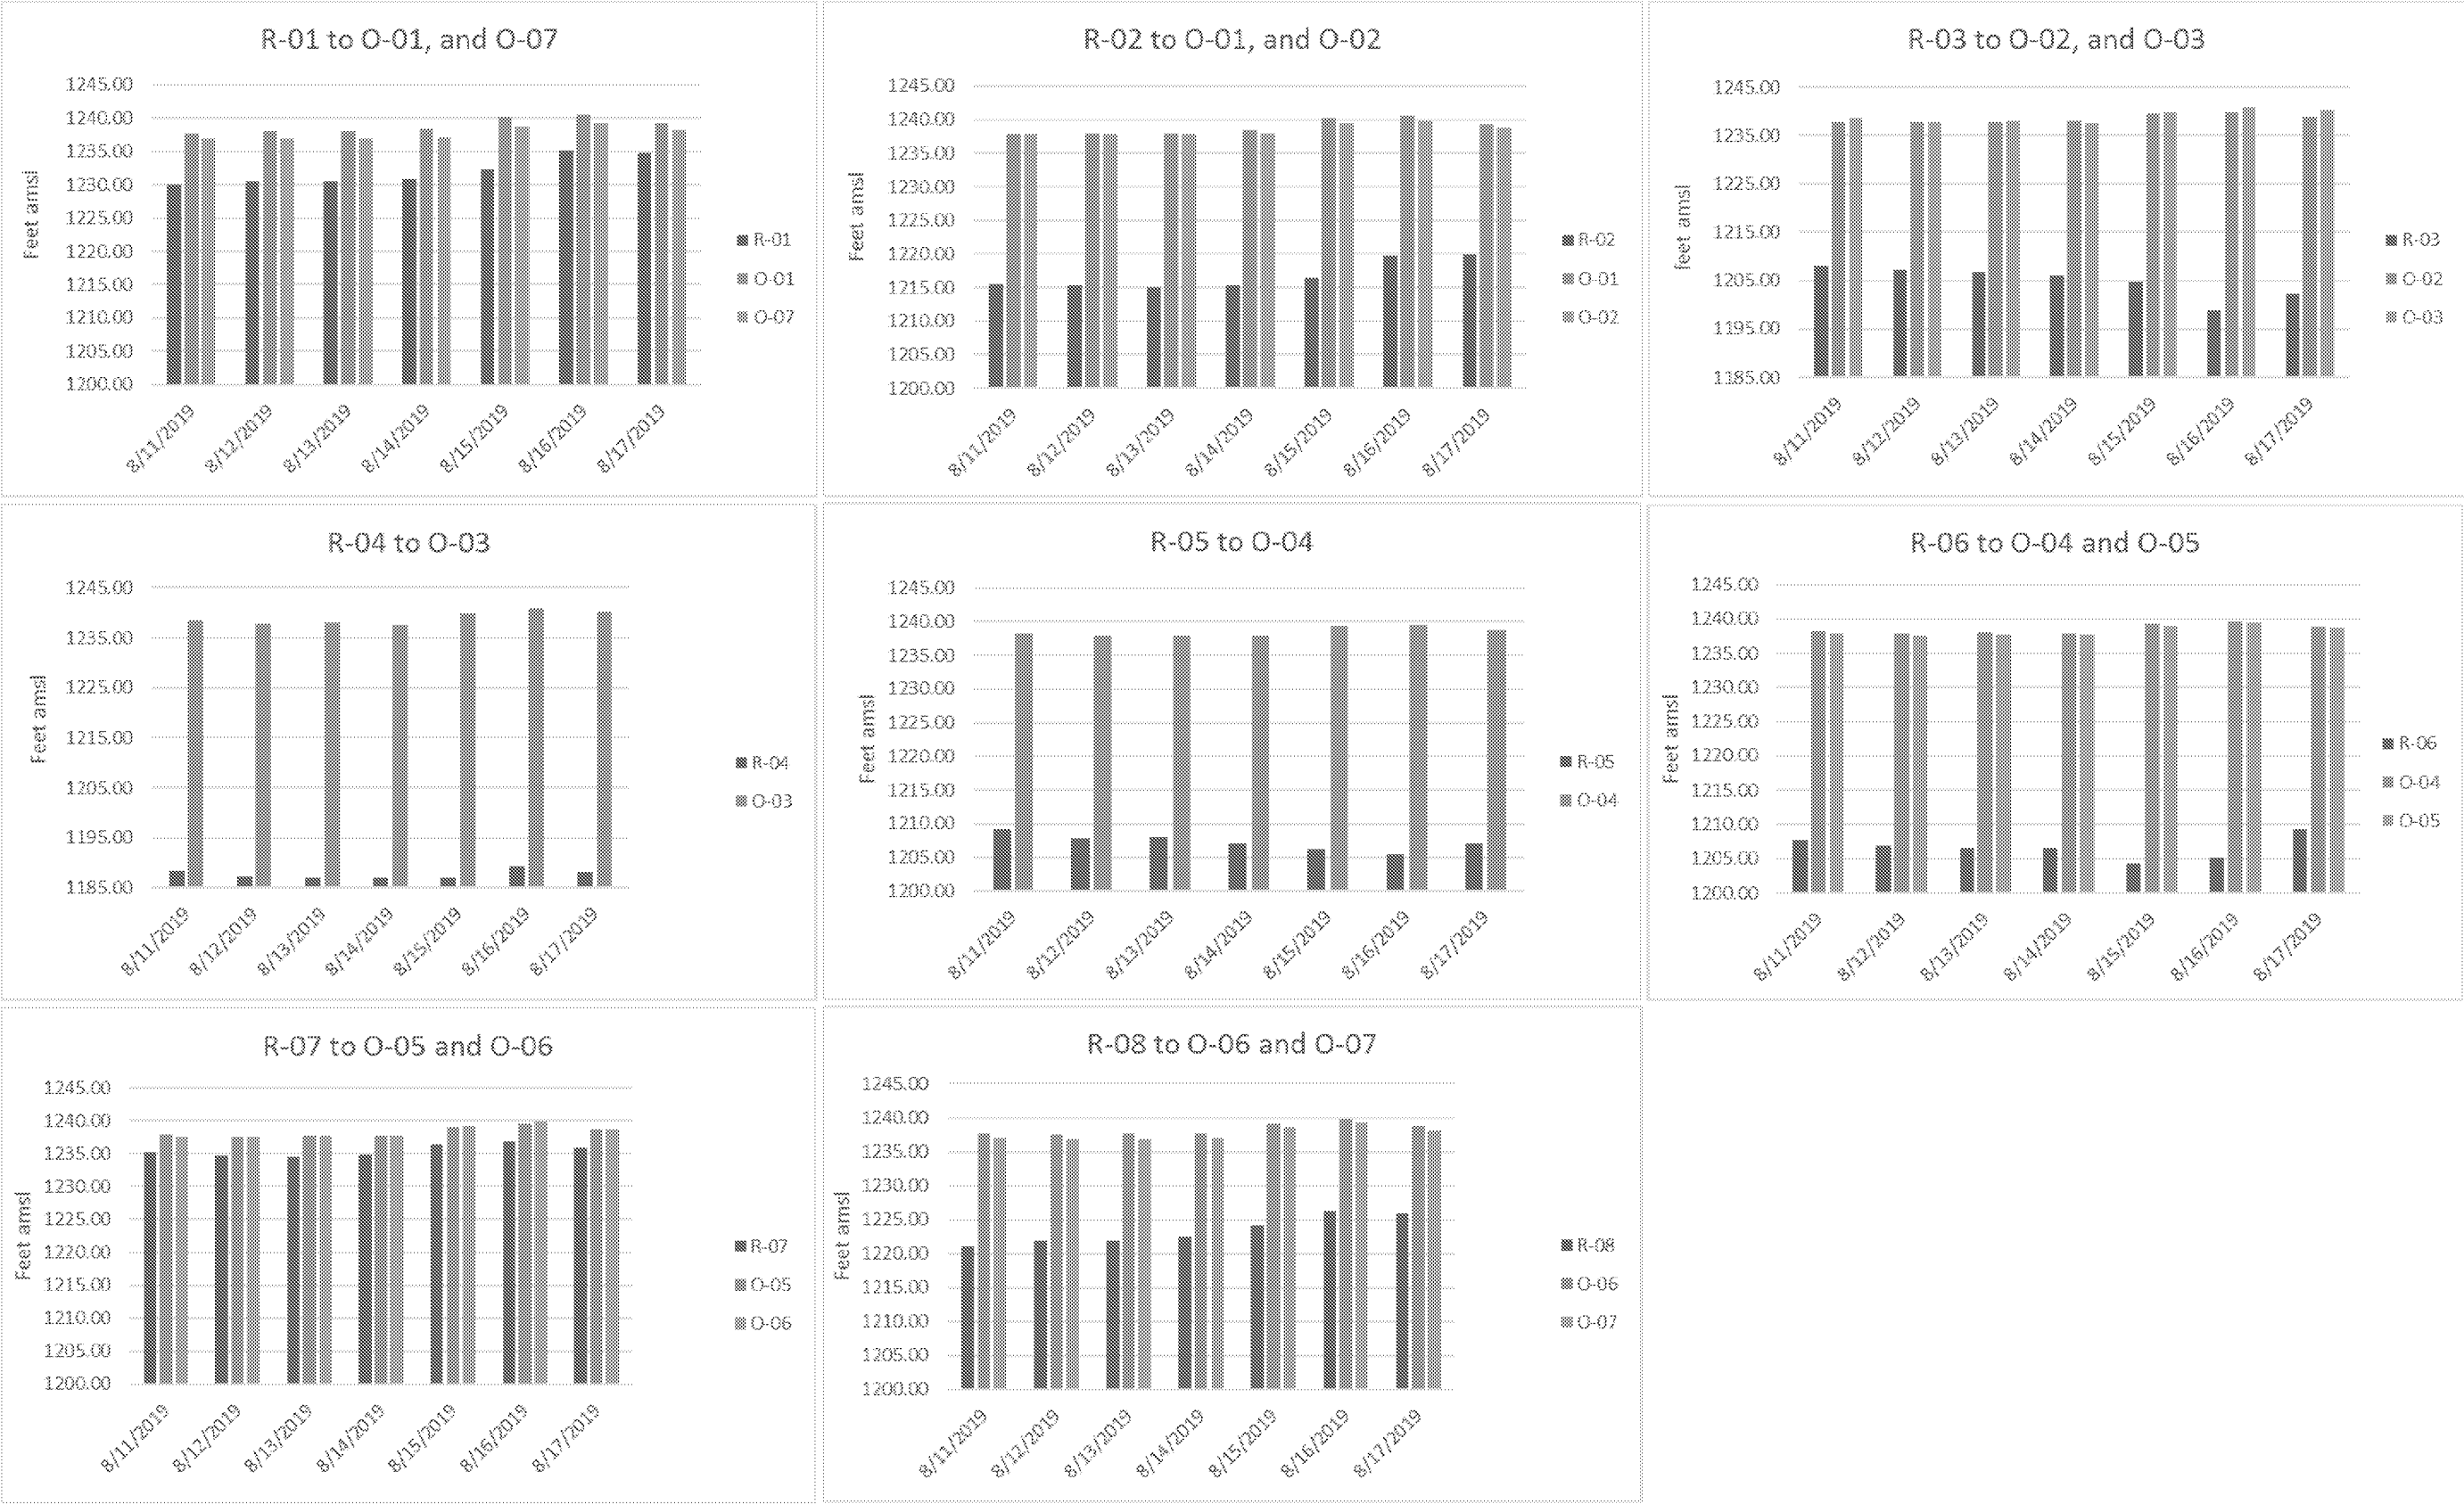
Figure 3

Figure 3. Recovery and observation well pairs

Table 2 includes a summary of water levels in the recovery and observation well pairs. Hydrographs showing the water level elevation for each recovery well and observation well pair are included in Figure 3.

During the reporting period, there was no exceedance of the alert level for the inward hydraulic gradient. The alert level for the inward hydraulic gradient is that the water level elevation in the paired observation well must be a minimum of 1 foot higher than the paired recovery well.
